Our Crumbling Pathways: Maintenance Needs on the Charles River Paths

Developed by the Massachusetts Bicycle Coalition (MassBike) Metro Boston Chapter

September 2006

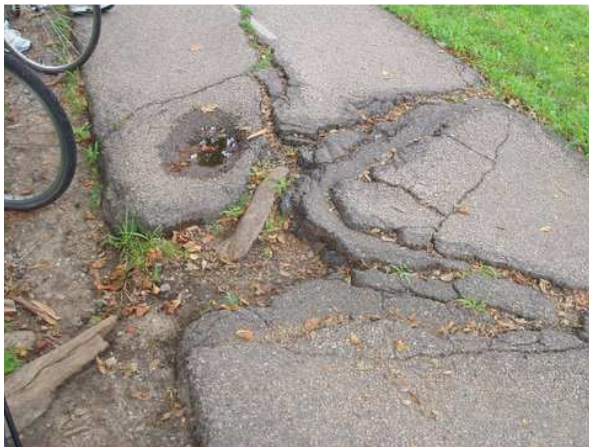
- 4) North side between JFK Street and Fresh Pond Parkway (Cambridge) – This segment suffers from thermal expansion cracks, root heave (primarily near the BB&N Boathouse), and potholes (Figure 1). It also has some severe edge drop-offs; in some cases (especially closer to JFK Street) these could be addressed through filling and packing of the adjacent ground.

Figure 1 Root Heave, Cambridge, East of Eliot Bridge

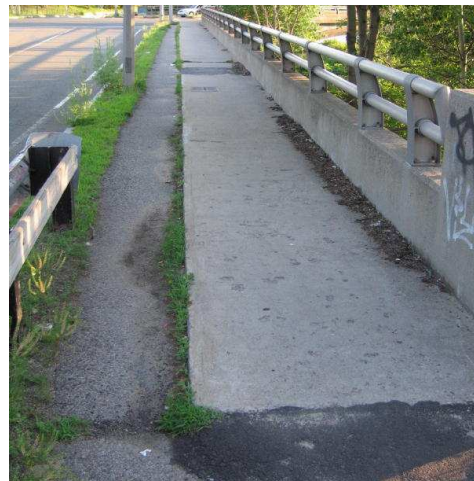
- 5) South side, approaching Arsenal Street from the east (Boston) – Just before the intersection there is a short segment with a pavement differential between concrete on the

riverside and an asphalt strip on the roadside (Figure 2). Combined with the narrow path cross-section and presence of signs in the path, the pavement differential creates a hazard because cyclists cannot safely transition from the lower asphalt pavement to the higher concrete if they need to maneuver to avoid another path user.

Figure 2 Pavement Differential, Boston, East of Arsenal Street

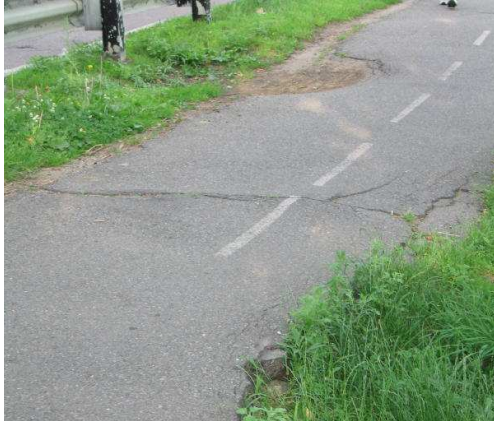
Figure 3 Large Pothole, Cambridge, Across from Hawthorne St.

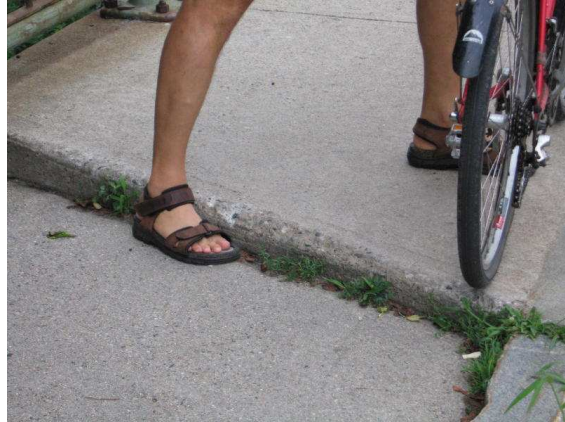
Figure 4 Transition Over Railroad Bridge east of BU Bridge

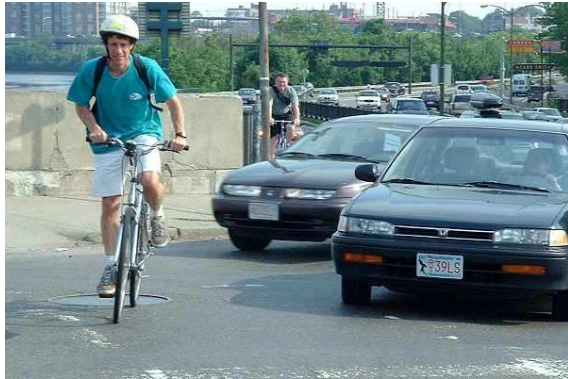
- 1) **Intersection of the south bank pathway with Cambridge Street** in Boston. This intersection does not have a pedestrian phase or signalhead and has heavy volumes of right-turn traffic that conflict with path users even when the parallel road (Soldiers Field Road access road) has a green (Figure 5). Curb cuts are oddly placed (Figure 6). The recommended fixes are:
 - a) Add a pedestrian signal phased concurrently with the northbound Soldiers Field Road traffic.
 - b) Add new curb cuts on the north side of Cambridge Street aligned with the pedestrian crossing.
 - c) Repaint pedestrian crossings for alignment with new curb cuts.

Figure 5 Crossing With No Pedestrian Signal at Cambridge Street, Boston

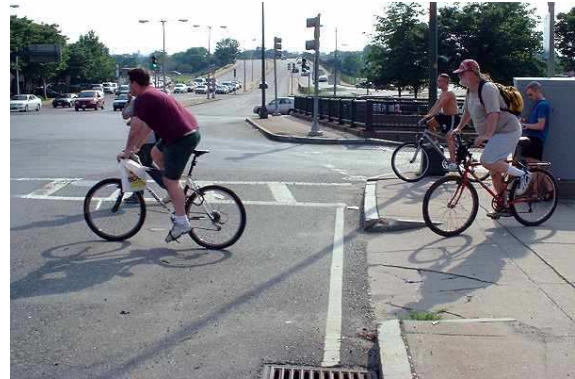
Figure 6 Oddly Placed Curb Cut at Cambridge Street, Boston

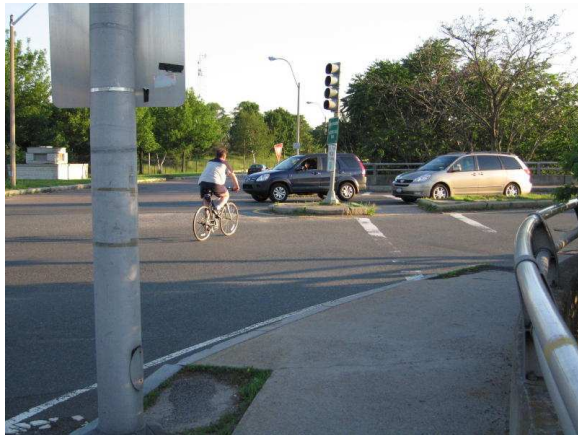
- 2) **Intersection of the south bank pathway with the western intersection of Western Ave.** (at Birmingham Parkway/Arsenal Street) in Boston (Figure 7). This signal does not have a pedestrian light. Therefore, it is left to the path user to guess when it is safe to cross – a potentially hazardous undertaking, especially as the user needs to contend with right-turning traffic that may turn on any phase. Recommended fixes (diagrammed in Appendix B) include:

Figure 7 Crossing With No Pedestrian Signal at Western Ave./Arsenal Street, Boston

- a) Add a pedestrian signalhead with the walk phase operating concurrently with the parallel traffic green light along Soldiers Field Road;
 - b) Place a stop sign and stop bar in the right turn lane from Soldiers Field Road to Western Ave., short of the crosswalk;

- c) Install “pedestrian crossing” signs on the approaches (Soldiers Field Road right turn lanes westbound, and Western Ave. right lane eastbound); and

- d) Widen curb cuts to make it easier and safer for opposing bicycle and pedestrian traffic to maneuver at the intersections.

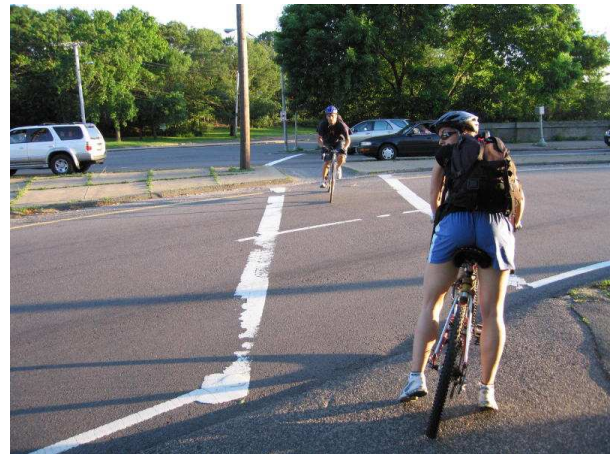
- 3) **Intersection of the south bank pathway with North Beacon Street** in Boston (Figure 8). Users must cross in two steps – the first across a two-lane free-right that has relatively high-speed traffic, and the second across a signalized intersection that does not have a pedestrian phase. The second step also involves contending with right turns from North Beacon southbound to Nonantum Road westbound. Recommended fixes include (diagrammed in Appendix B):

Figure 8 Crossing With No Pedestrian Signal at North Beacon Street, Boston

- a) A pedestrian signal added to the existing light that would operate concurrently with through westbound traffic from Soldiers Field Road to Nonantum Road, along with a signal in the island facing west, and prohibition of right turns on red for traffic eastbound on North Beacon Street to Nonantum Road westbound;

- b) A signal for right-turning traffic from Soldiers Field Road to North Beacon that would allow an activated pedestrian-only phase requiring the right-turning vehicles to stop;

- c) If (b) is not feasible in the short term due to cost or other reasons, place a stop or yield sign for right-turn traffic from Soldiers Field Road to North Beacon St. short of the existing crosswalk, along with signs warning of the pedestrian crossing.

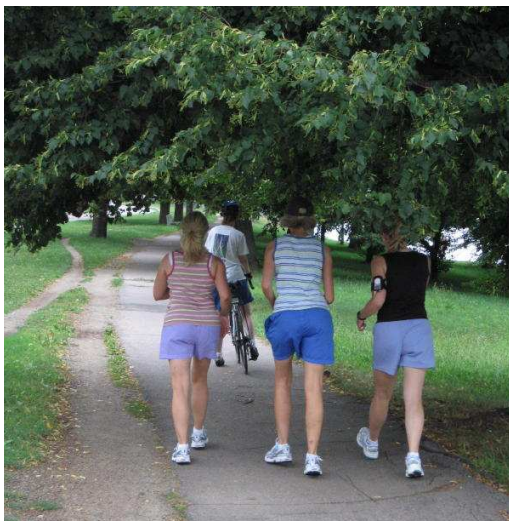
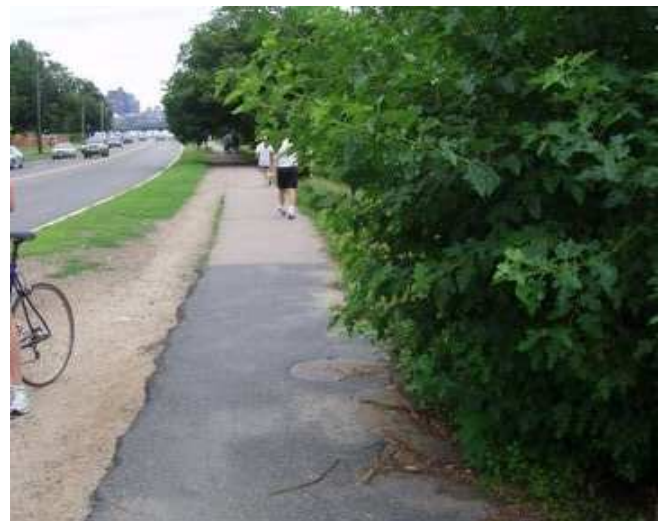
- 1) North side path from the BU Bridge to River Street in Cambridge (overhanging tree branches and encroaching shrubbery) (Figure 9, 10).
- 2) South side path between Arsenal Street and North Beacon Street in Boston (encroaching trees and shrubbery).
- 3) North side path along Greenough Boulevard in Cambridge/Watertown; specifically, two segments just west of Fresh Pond Parkway and slightly farther west adjacent to a section of guardrail that separates the path from the road.
- 4) North side of the path, along Charles River Road in Watertown between North Beacon and Galen Streets; one particular segment in the middle of this stretch.
- 5) North side, west of Galen Street in Watertown.
- 6) South side, east of Chapel Street in Newton.
- 7) South side, west of Newton Street in Waltham.

Figures 9 and 10 Vegetation Encroachment, Cambridge

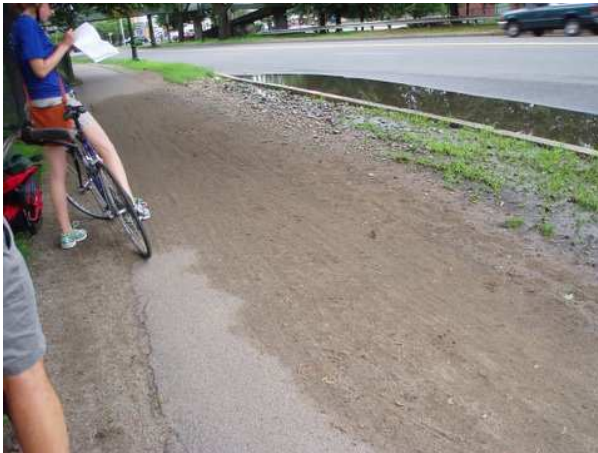
Figure 11 Debris Accumulated on Path, Near Magazine Street, Cambridge

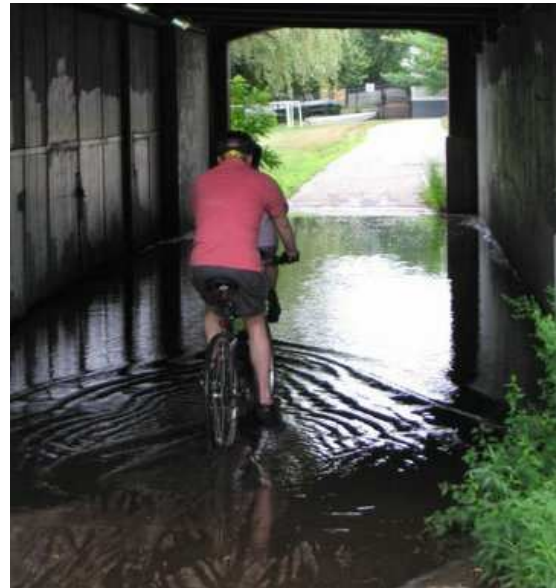
Figure 12 Water and Mud Accumulation, Eliot Bridge, Cambridge

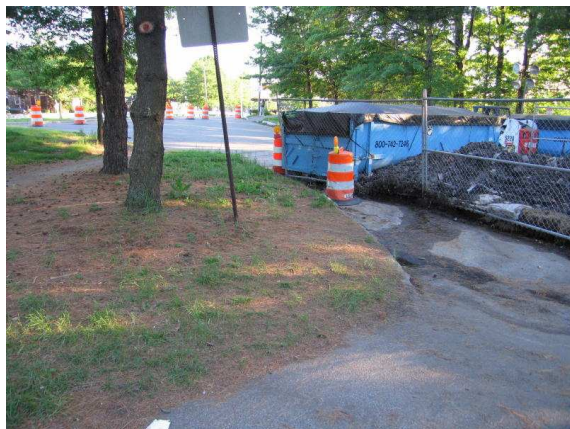
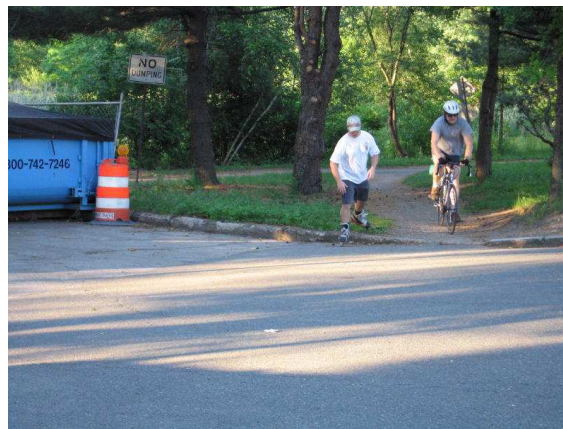
- 1) **Maintenance equipment placed in the middle of the path.** Dumpsters blocking the path in the parking lot east of Arsenal Street were noted in June 2006 and were still present in August. The blockage is nearly complete, forcing all path users onto a dirt path detour (Figures 13 - 14). This is particularly a problem for inline skaters as well as for bicyclists in wet weather, when the dirt path turns to mud. Examples of leaving equipment, mulch, etc. in the middle of the path also are not uncommon. These problems suggest a potential lack of awareness among some agency staff to the needs of path users and should be addressed comprehensively through adoption of a policy not to block the path, and through internal agency training and education on this policy

Figures 13 - 14 Dumpsters Blocking Path, East of Western Ave./Arsenal Streets, Boston

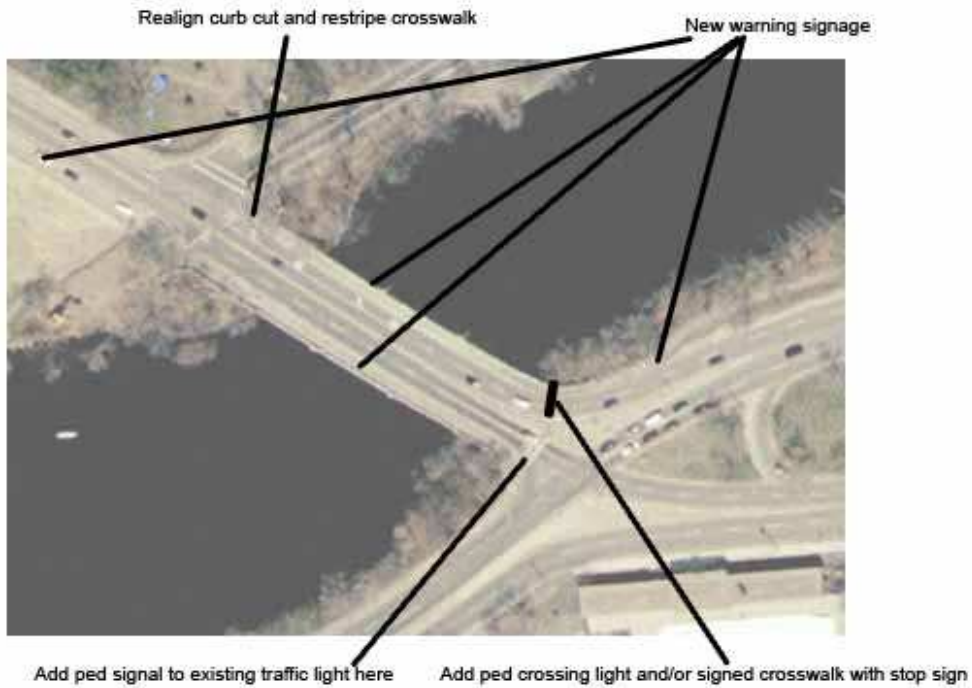
Crossing of the path from North Beacon Street to Greenough Boulevard
& Intersection of the south bank pathway with North Beacon Street

- 5) **Crossing of the path from North Beacon Street to Greenough Boulevard** in Watertown (diagrammed in Appendix B). There is no existing signal here. The road is wide and traffic moves relatively fast, and westbound traffic on North Beacon comes over a blind crest on the bridge over the Charles River. Cyclists and pedestrians crossing North Beacon must also contend with left turning traffic from westbound Greenough Boulevard, which waits for the same gaps as the non-motorized crossers. This intersection is a good candidate for traffic calming features such as bulb-outs/neck-downs at the pedestrian crossings. Recommended short-term, low-cost improvements include:

- a) Creating another curb cut on the north side of North Beacon Street, to provide bicyclists with better visibility of motorists coming over the bridge from the right. The current curb cut is located so that the bridge parapet obscures the view of approaching traffic.

- b) Restriping the crosswalk and realigning with the new curb cut.
 - c) Placing signage on both the eastbound and westbound approaches of North Beacon Street alerting motorists to the crossing.
